Water Project in Ebonyi State Nigeria – 2020 Final Report

SPONSORED BY
Rotary

Club of Casalmaggiore
Viadana Sabbioneta
ITALY

IN COOPERATION WITH
AMURT FOUNDATION

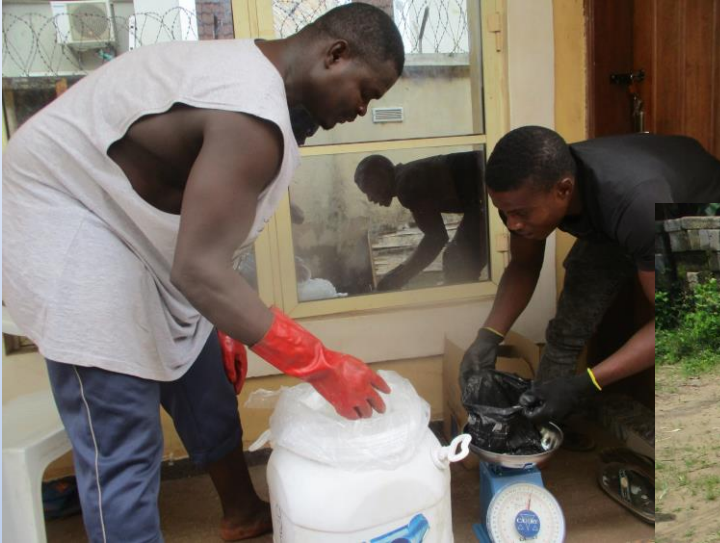
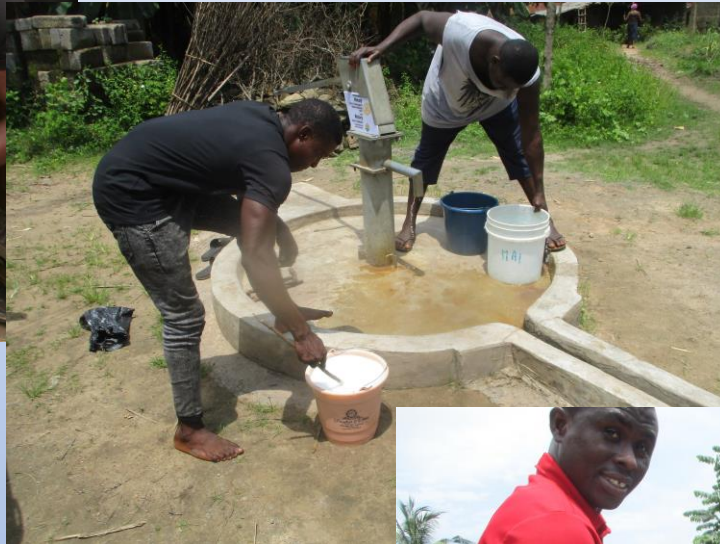
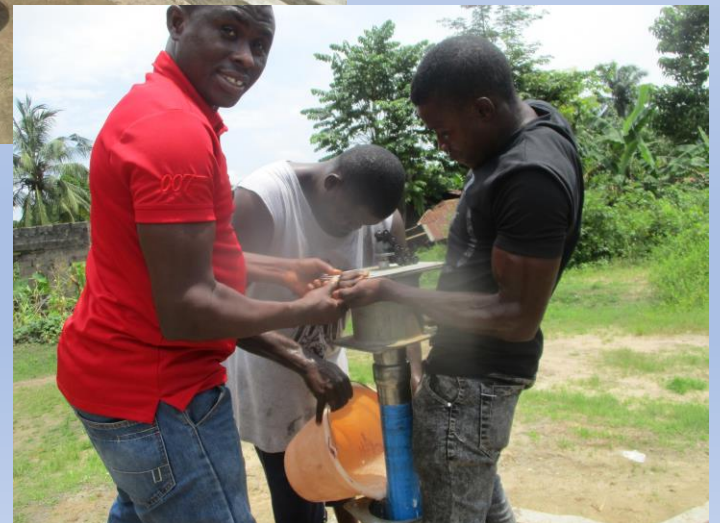
DISINFECTION OF BOREHOLES

USING CHLORINE FOR DISINFECTION – All 30 boreholes were disinfection with chlorine between 27th August and 2nd September.

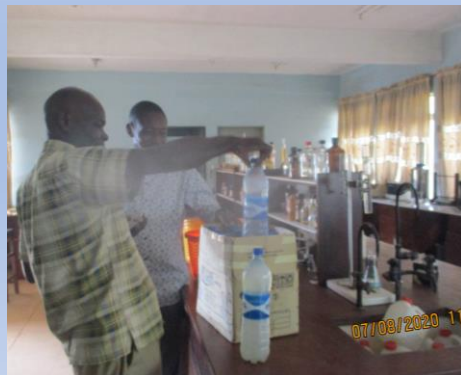
LABORATORY WATER QUALITY TEST

RESULT: Some of the samples analyzed indicate challenges which includes; total plate count, total coli form and turbidity. Treatment / disinfection were recommended to address these challenges. Between 27 August and 2nd September all the 30 boreholes were disinfected with chlorine.

Four villages had high turbidity. They are Ndiudeagha Amangwu Edda Afikpo South LGA, Onunwankwo 1 Ishielu LGA, Amanakwa Amazu Ishielu LGA and Ndiuduma OsoEdda Afikpo South LGA. Flushing was recommended. We had originally budgeted for flushing five boreholes. However, due to rise in the cost of borehole materials, as a result of corona virus impact on the economy, we had to cut flushing from our budget. We are looking at alternative funding to complete the flushing of three of these boreholes. The fourth, Amanankwa is currently inaccessible due to collapse of the road

17	LEAD (Pb)	mg/L	0.017	0.01	0.01
18	SULPHATES (SO ⁴)	mg/L	2.50	200	200
19	NITRATES (NO ³)	mg/L	0.89	10	50
20	MANGANESE (Mn ²⁺)	mg/L	0.026	0.1	0.2
21	CALCIUM ION (Ca ²⁺)	mg/L	77.2	150	-
22	MAGNESIUM ION (Mg ²⁺)	mg/L	2.1	50	20
23	TOTAL PLATE COUNT	cfu/mL	111.0 *	100	-
24	TOTAL COLIFORM	cfu/mL	14.0 *	3.0	10
25	E.COLI	cfu/mL	2.0 *	-ve	0.0

- THE WATER SAMPLE ANALYSIS RESULT INDICATE BACTERIOLOGICAL CHALLENGES (TOTAL PLATE COUNT AND TOTAL COLIFORM).
- TREATMENT AND DISINFECTION MAY BE APPLIED TO IMPROVE WATER QUALITY.
