Water Project in Ebonyi State Nigeria – 2020 Final Report

SPONSORED BY
Rotary

Club of Casalmaggiore
Viadana Sabbioneta
ITALY

IN COOPERATION WITH
AMURT FOUNDATION

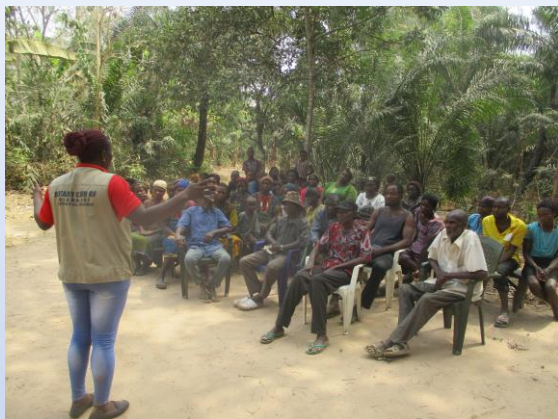
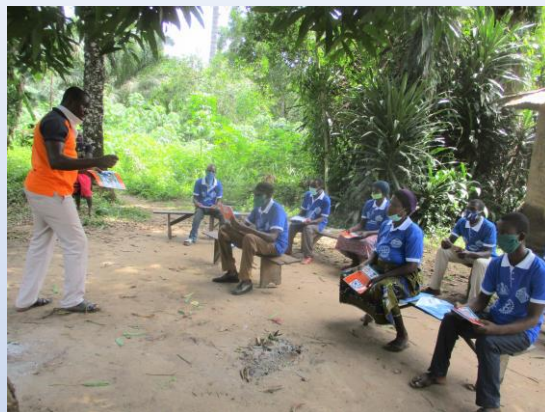
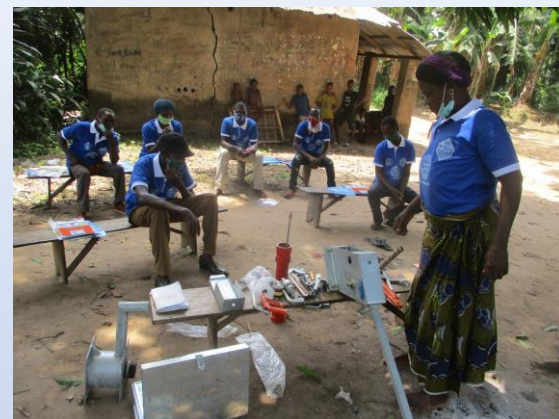
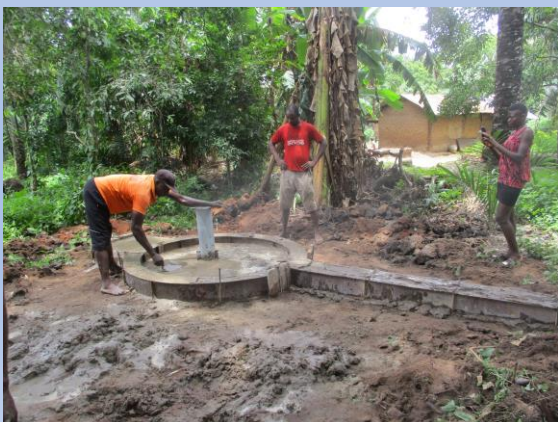
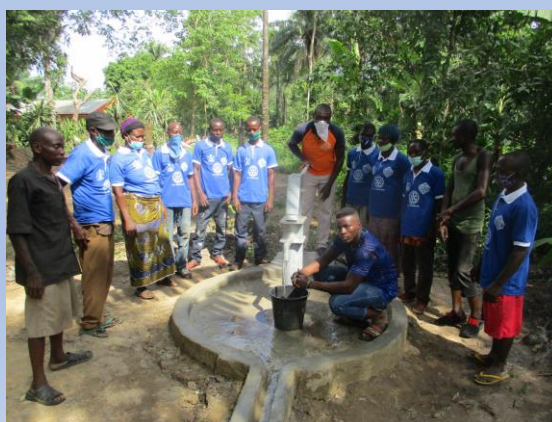
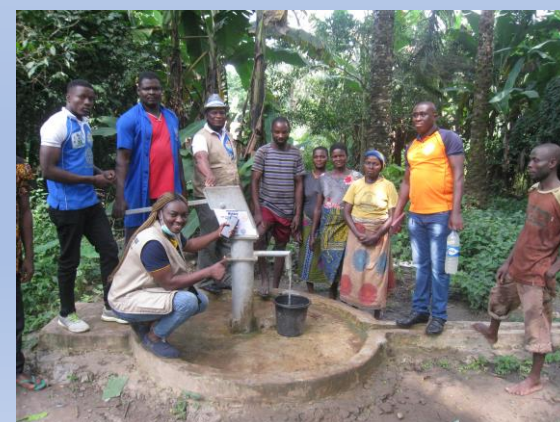
AMANAKWA, AMAZU COMMUNITY, ISHIELU LGA

Drilled	12 March	PHOTOS	1	2	3
Installed	19 May	Top	Village sensitization	WASHCOM training	WASHCOM training
Depth	130 feet	Bottom	Platforming	Completion of installation	Rotary visit
Notes:	The first borehole to be installed. Water turbidity not good. Needs flushing. Road to borehole collapsed

Four villages had high turbidity. They are Ndiudeagha Amangwu Edda Afikpo South LGA, Onunwankwo 1 Ishielu LGA, Amanakwa Amazu Ishielu LGA and Ndiuduma OsoEdda Afikpo South LGA. Flushing was recommended. We had originally budgeted for flushing five boreholes. However, due to rise in the cost of borehole materials, as a result of corona virus impact on the economy, we had to cut flushing from our budget. We are looking at alternative funding to complete the flushing of three of these boreholes. The fourth, Amanankwa is currently inaccessible due to collapse of the road

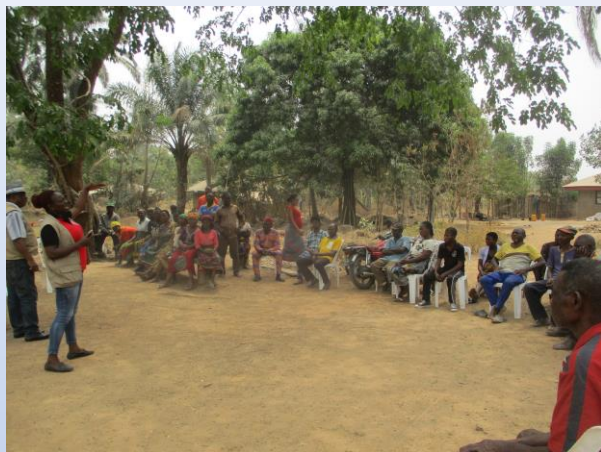
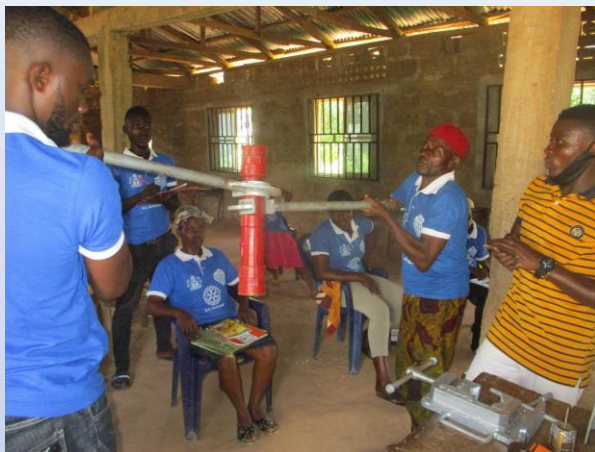
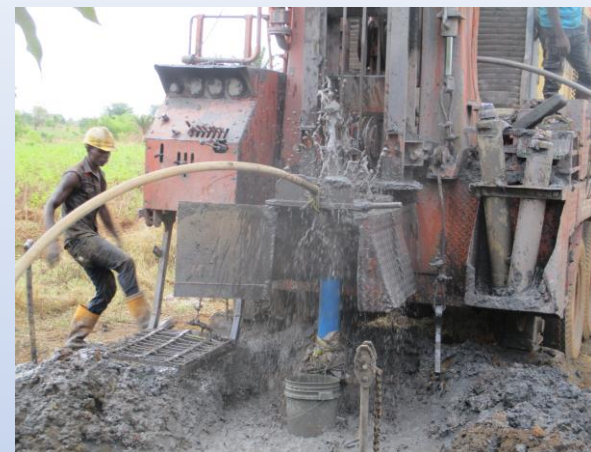
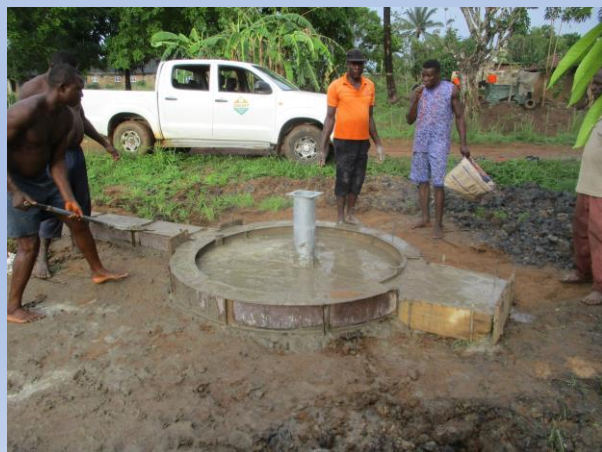
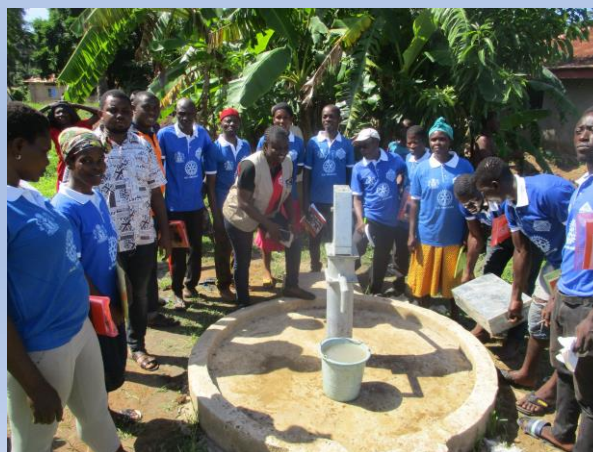
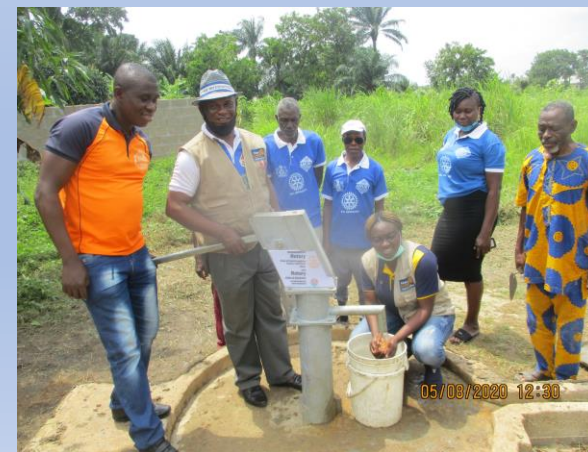
ONUNANWKOR 1, UMUHUALI COMMUNITY, ISHIELU LGA

Drilled	24 March	PHOTOS	1	2	3
Installed	27 May	Top	Village sensitization	WASHCOM training	Drilling
Depth	130 feet	Bottom	Platforming	Completion of installation	Rotary visit
Notes:	The borehole will benefit from flushing to improve turbidity

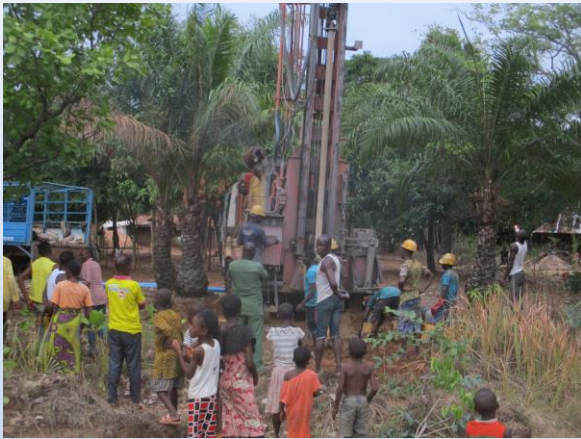
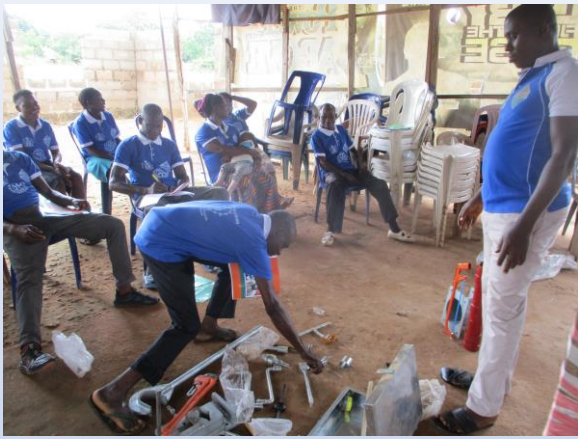
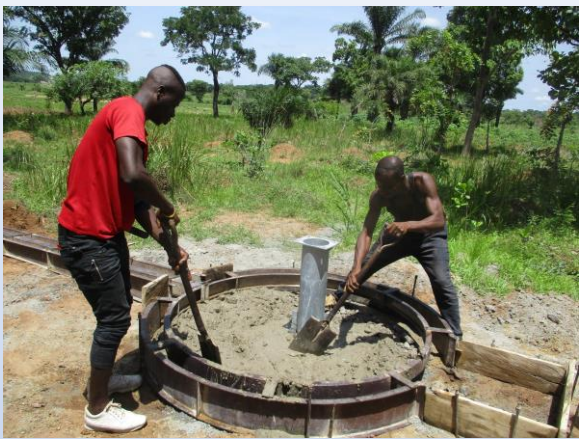
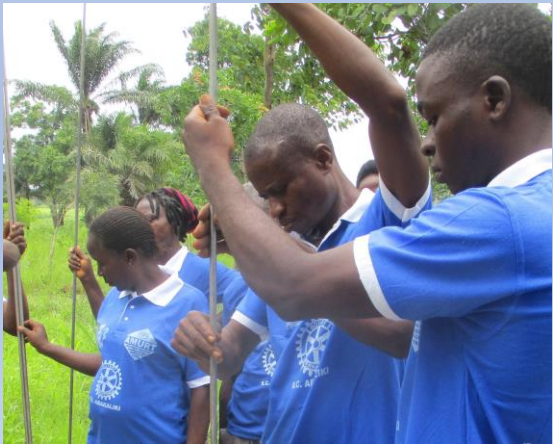
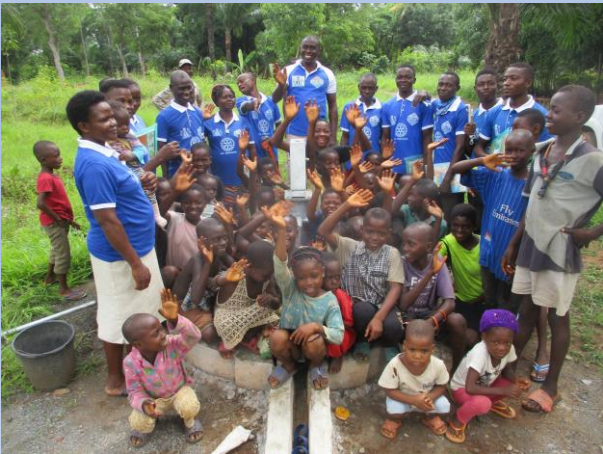
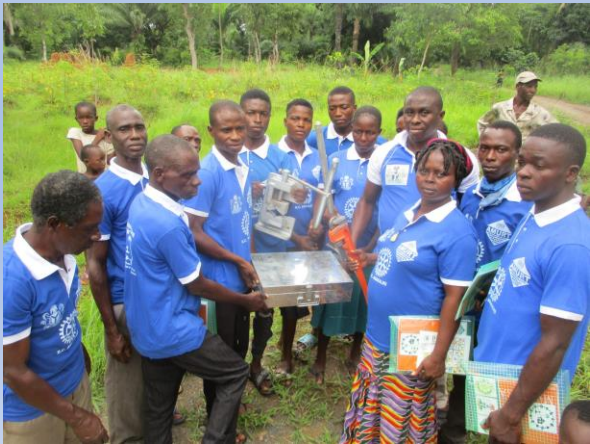
BILODE ULEPA, NTEZI COMMUNITY, ISHIELU LGA

Drilled	24 March	PHOTOS	1	2	3
Installed	27 May	Top	Drilling	WASHCOM training	Platforming
Depth	130 feet	Bottom	Installing connecting rods	Completion of installation	Handing over tool box
Notes:	The village was selected to replace Gioke Obegu village. The village was not accessible due to the collapse of a culvert.

S/N	VILLAGE/COMMUNITY	LGA	REPLACED	LGA	REASON(S) FOR REPLACEMENT
1	Gioke Obegu	Ishielu	Bilode Ulepa Ntezi	Ishielu	There was a collapsed culvert to the community which makes the drilling machines unable to access the village after spending more than 24 hours in the area; and the community members were not able to fix alternative access.
2	Amagbo EziEdda	Afikpo South	Ndiuduma Oso Edda	Afikpo South	After conducting geophysical survey in the areas, all the locations proved abortive. This led to the change of the village to Ndiuduma OsoEdda.
3	Ufueseni Owuttu Edda	Afikpo South	Ndiobasi Oso Edda	Afikpo South	Geophysical survey report reveals that the areas cannot be feasible with hand pump boreholes. It stated that one must drill between 350ft to 400ft before getting low yield water
4	Amoso Edda	Afikpo South	Uhumba Umoke, Ntezi	Ishielu	The surveyed point in the area failed after drilling up to 60m. Also, the geophysical survey reveals that the area is not feasible for hand pump borehole(s).

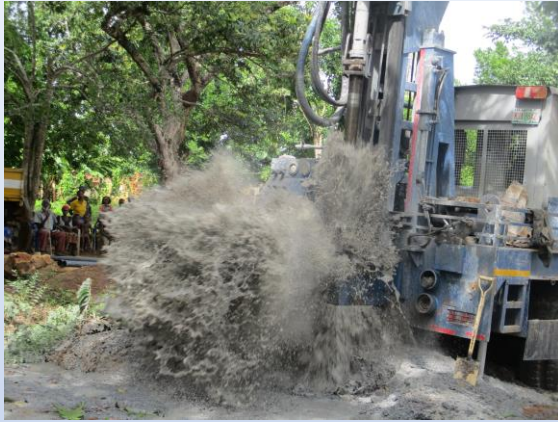
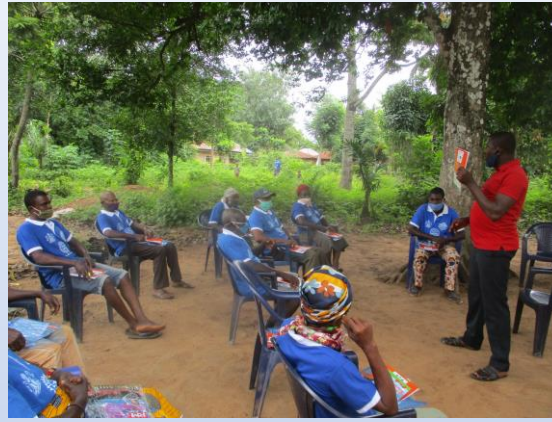
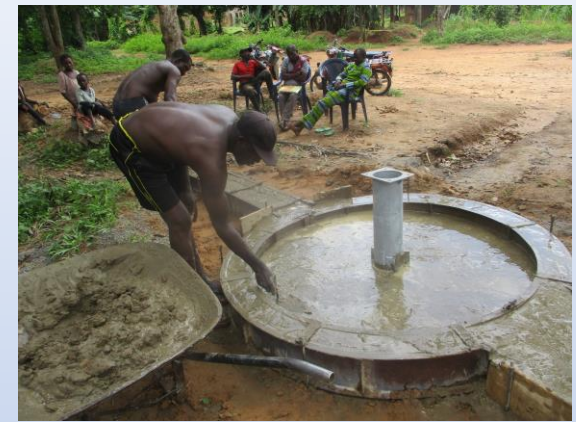
UHUMBA UMUOKE, UMUEZEOKA, NTEZI, ISHIELU LGA

Drilled	29 May	PHOTOS	1	2	3
Installed	23 June	Top	Drilling	WASHCOM training	Platforming
Depth	130 feet	Bottom	Installing connecting rods	Tasting first water	Completion of installation
Notes:	Uhumba Umoke villages was selected to replace Amoso Edda in Afikpo South LGA. The reason was that we drilled several times in Amoso Edda without finding water. After failing to locate reliable sources in the area we had to leave the place.

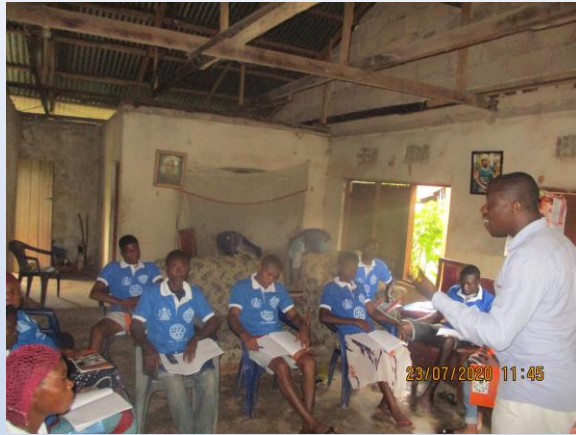
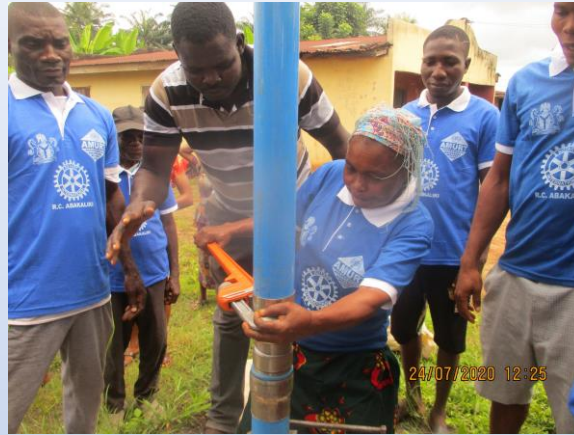
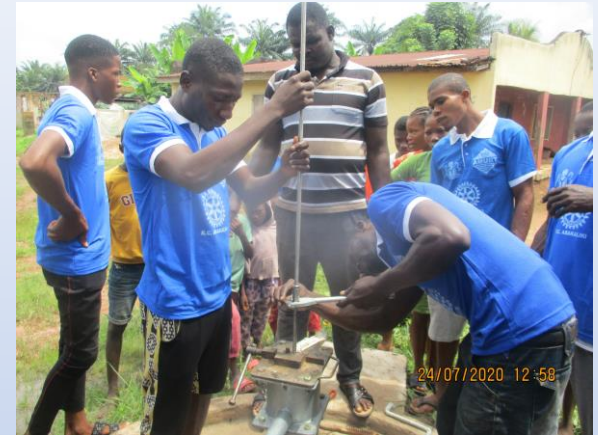
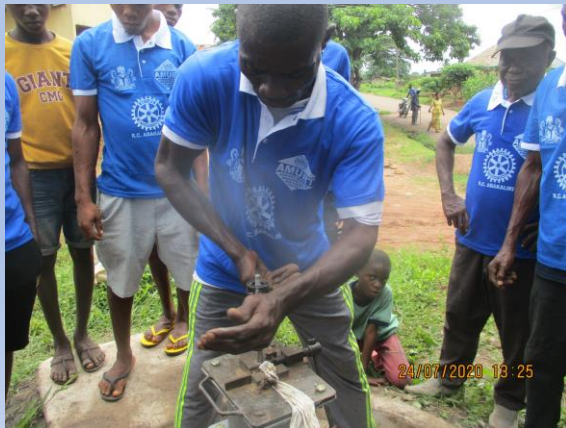
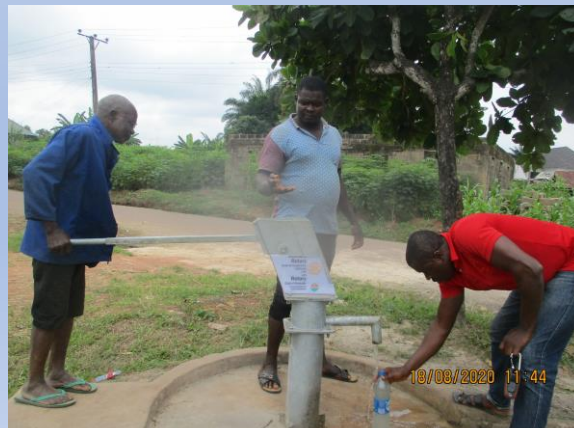
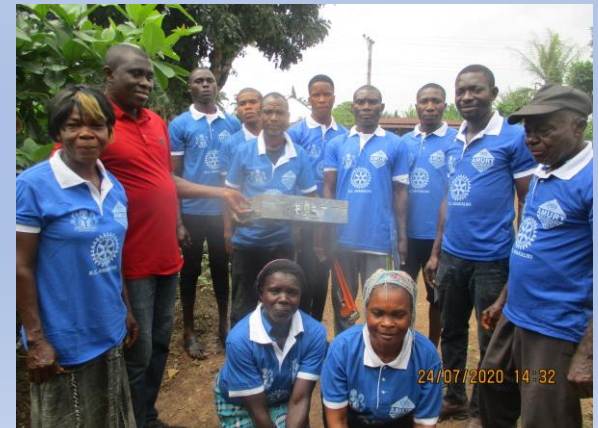
NDIUDEAGHA, AMANGWU EDDA, AFIKPO SOUTH LGA

Drilled	4 July	PHOTOS	1	2	3
Installed	24 July	Top	WASCHOM training	Installing pipes	Installing connecting rods
Depth	150 feet	Bottom	Installing connecting rods	Visit with signage	Handing over tool box
Notes:	The water has high turbidity and will benefit from flushing

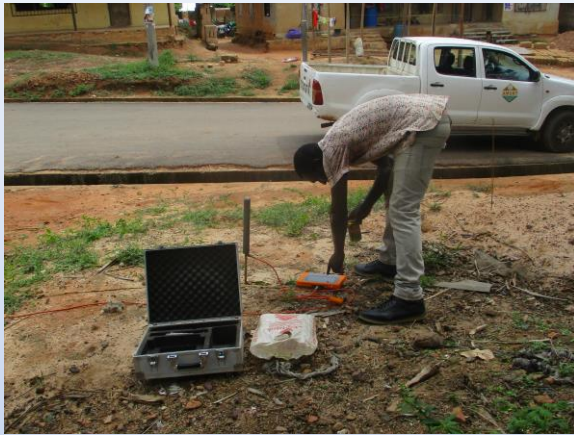
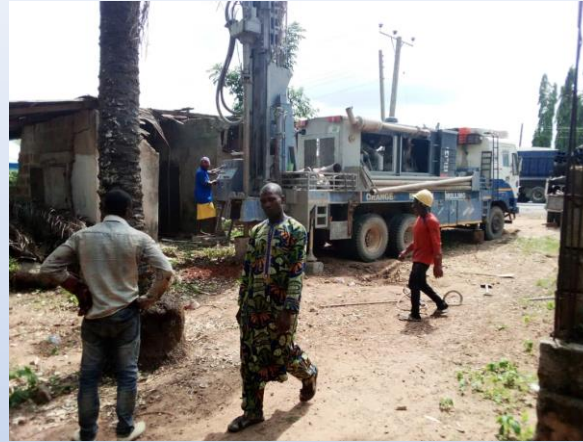
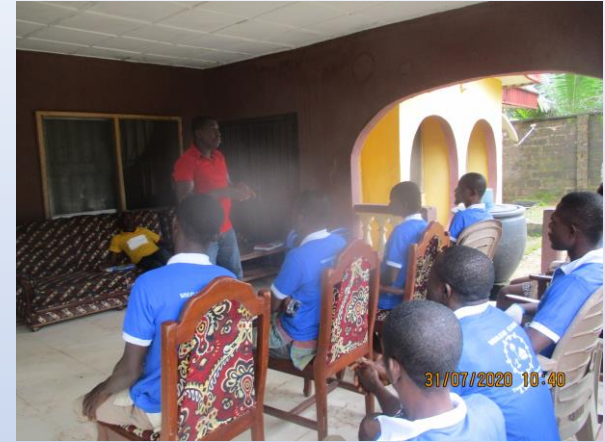
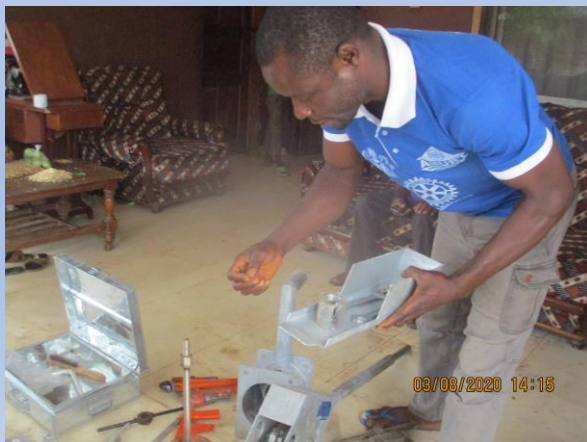
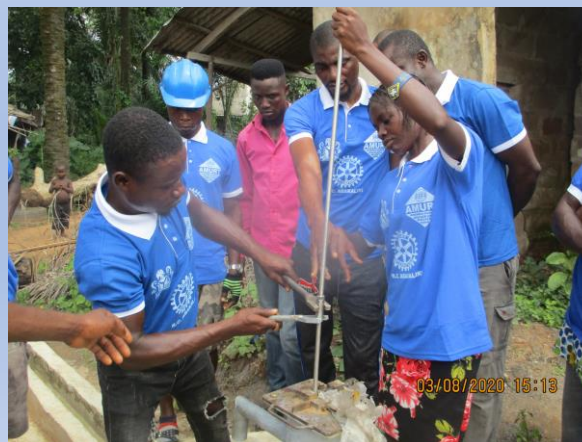
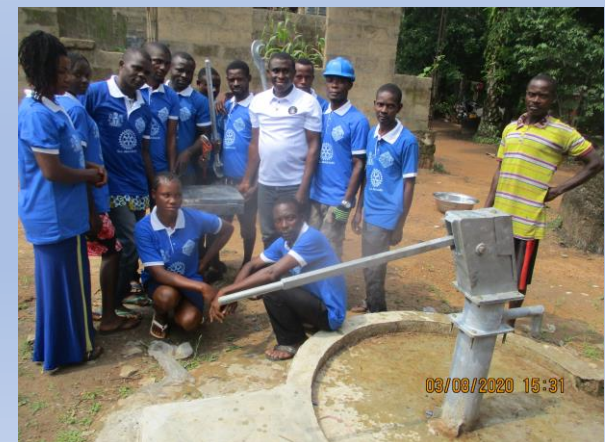
NDI UDUMA, OSO EDDA COMMUNITY, AFIKPO SOUTH LGA

Drilled	18 July	PHOTOS	1	2	3
Installed	3 August	Top	Geophysical survey	Drilling	WASHCOM training
Depth	150 feet	Bottom	WASHCOM training	Installing connecting roes	Completion of installation
Notes:	Ndi Uduma was selected to replace Amagbo EziEdda. We conducted geophysical but could not locate reliable source of water in the village. The water has turbidity and will benefit from flushing.

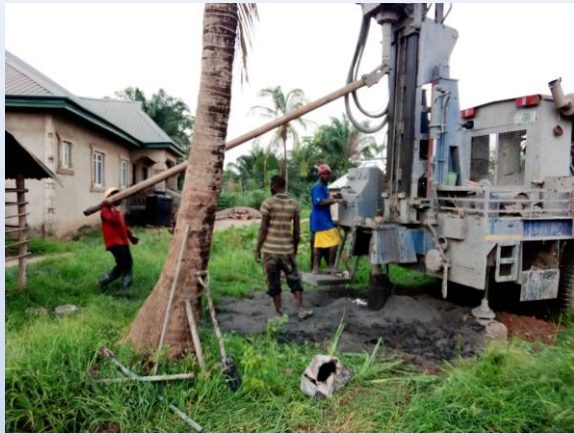
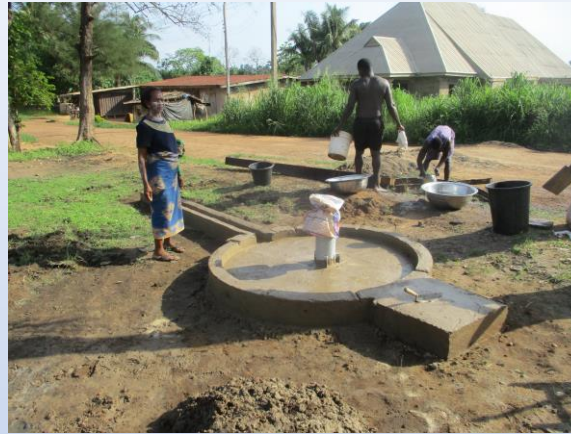
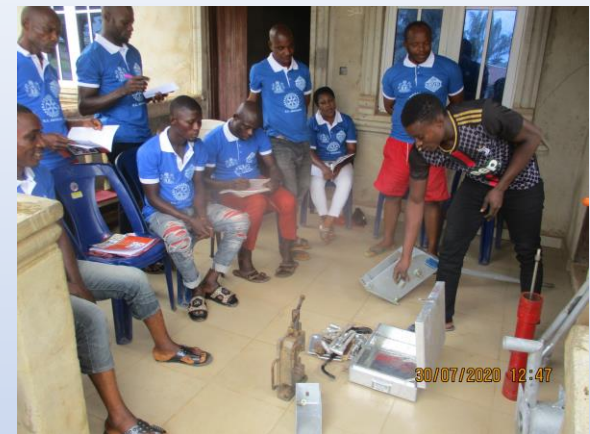
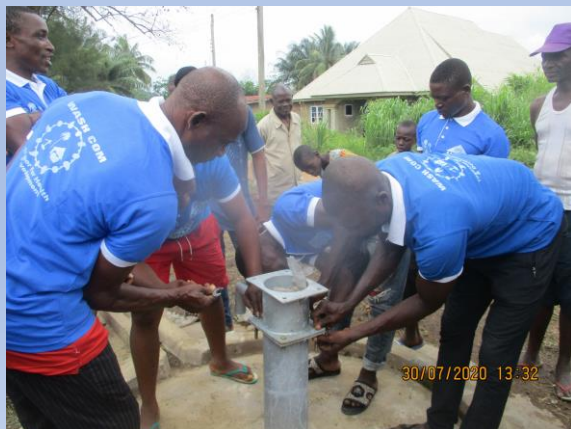
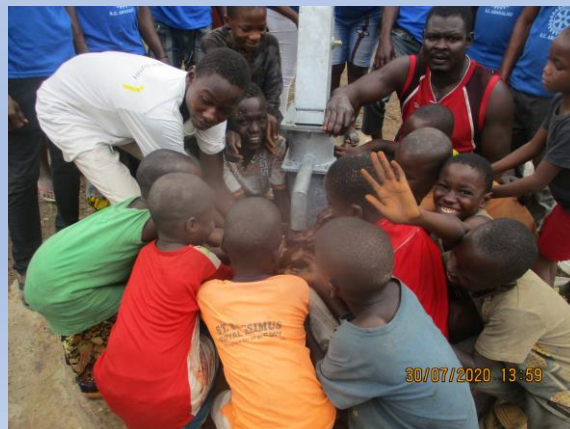
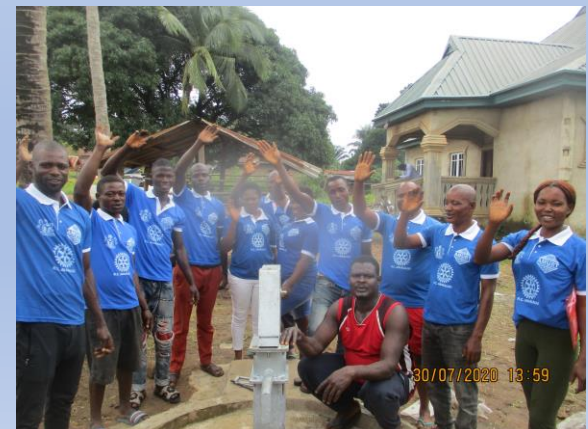
NDIOBASI, OSO EDDA COMMUNITY, AFIKPO SOUTH LGA

Drilled	18 April	PHOTOS	1	2	3
Installed	30 July	Top	Drilling	Platforming	WASHCOM training
Depth	115 feet	Bottom	Installing head assembly	Tasting first water	Completion of installation
Notes:	Ndi Obasi was selected to replace Ofueseni Owuttu Edda. The geophysical survey revealed that water was only available at a depth of 350 to 400 feet, which is not feasible for hand pumps.
